INDIANA DEPARTMENT OF ENVIRONMENTAL MANAGEMENT
We make Indiana a cleaner, healthier place to live

Re: Gary Development Company Landfill
RCRA Docket No. RCRA-V-W-86-R-45
EPA I.D. No. IND 077 005 916

On November 19, 1996, a visit to the above-captioned site was made by myself and Mr. Kirk Maravolo of the Indiana Department of Environmental Management, representatives of U.S. EPA Region V, and Mr. Steve Cherry and Ms. Lisa McKinney from Bose, McKinney & Evans. Enclosed, as previously requested, are two (2) additional photographs that were obtained by Mr. Maravolo during this visit.

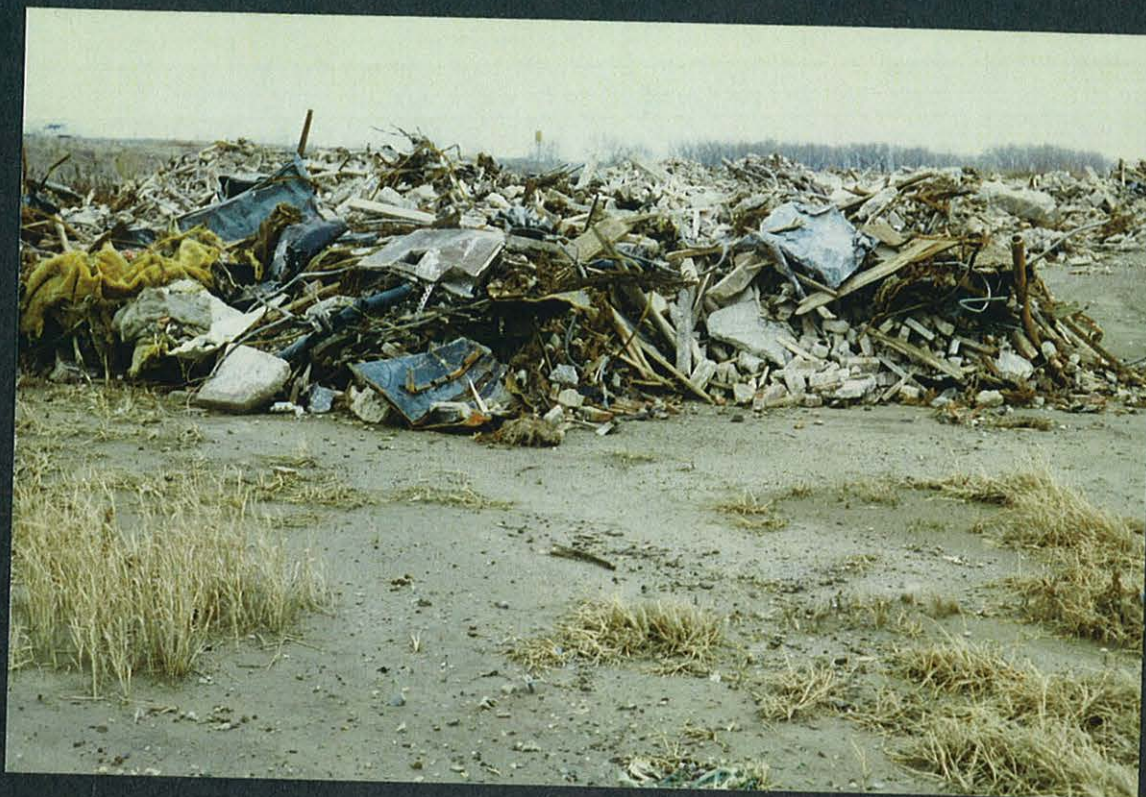
11-19-96 M. Mikulka
Gary Development Landfill
#24A -- Solid waste material
(demolition debris) dumped at
GDC landfill since closure of
facility. This material is located at
northwestern portion of the
landfill, at top of slope adjacent to
leachate/storm water collection
pond. See also photo #19.
